IMPORTANT PRODUCT INFORMATION

Product: PACSystems™ RX7i CPU Module (700 MHz)
CPU Firmware Version 3.80
Ethernet Firmware Version 3.60
IC698CRE020-FF

Firmware version 3.80 provides many of the features that previously existed only on the non-redundant RX7i controllers to the CRE020 redundant controller. (The RX7i Ethernet firmware remains at release 3.60.) New features in this release, which are all previously released in other PACSystems CPU products, are:

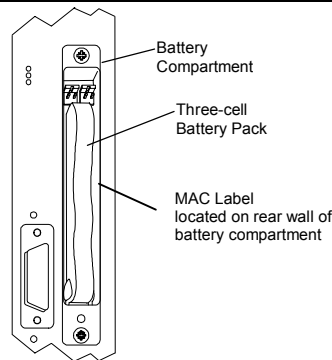
<i>Subject</i>	<i>Description</i>
MAC address	<p>A label on the rear wall inside the CPU's battery compartment identifies the MAC address assigned to the CPU's embedded Ethernet Interface. The label is visible when the battery is removed from its compartment. (The battery does not need to be disconnected to temporarily remove it from the compartment.)</p>
